MONUMENT RECORD
State of Indiana - County of Monroe

Corner ID: Polk G-15

RECOVERY TIE DRAWING
Field Book 39 Page No. 17

LAND CORNER RECORD

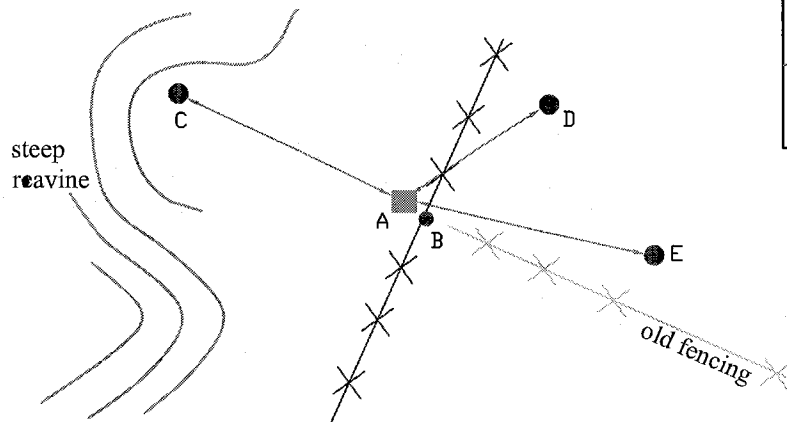
- A - Sandstone
- B - S 74° E 0.40' to Survey Sign on metal fence post
- C - S 76° W 27.57' to Sign on 17" White Oak
- D - N 18° E 20.82' to MAG nail in 17" Black Oak
- D - N 75° E 23.30' to MAG nail in 16" Red Oak

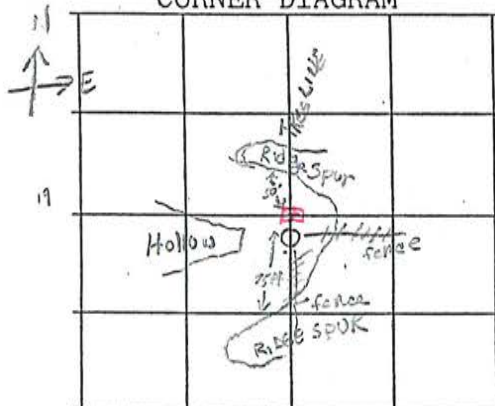
CORNER DIAGRAM

Accessories: Describe new Bt's and/or witness objects established or work done to preserve existing evidence
12" Hickory 13 1/2 feet south of stone
